# BEAM & FOLDING SYSTEM - CARE AND MAINTENANCE

**FARRIER MARINE, INC.**

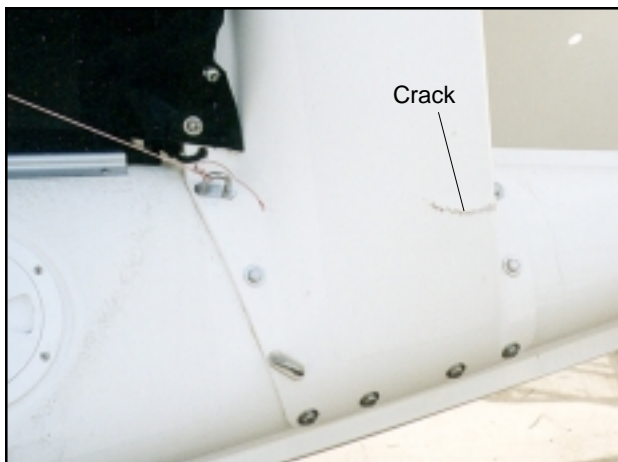
*The beam tops of this F-27 hit a low overhead bridge while being trailered. The crack visible in the top continues around the aft side. Such a crack should not be repaired as the carbon fiber inside is probably considerably weakened. The beam needs to be replaced otherwise it may suddenly fail*

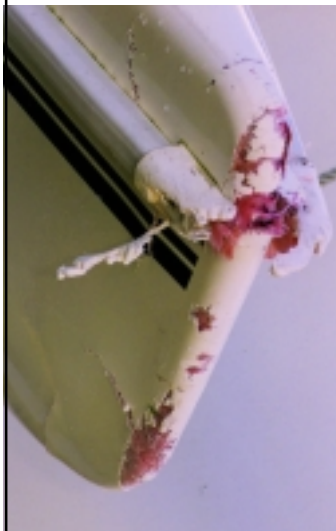
*If there is this much bow damage (F-31 float Bow)*

*Collision damage can be serious and beams should always be checked carefully and then monitored after any significant collision. Photos shown damage to an F-31 after a major float bow collision. Both beams were replaced as a precaution.*

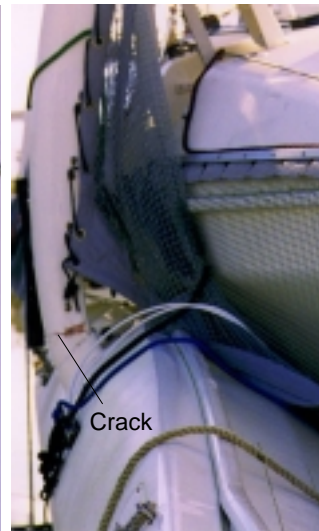
*...then fwd. beam may also be damaged (see crack on fwd. side)*

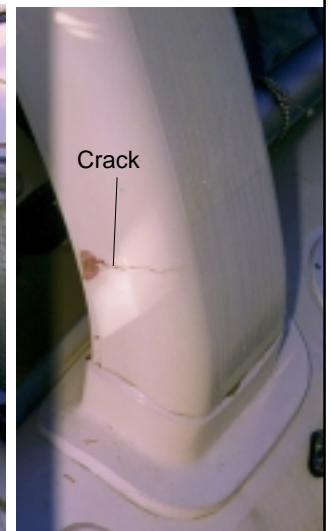
*...plus even the aft beam (aft side in this case)*

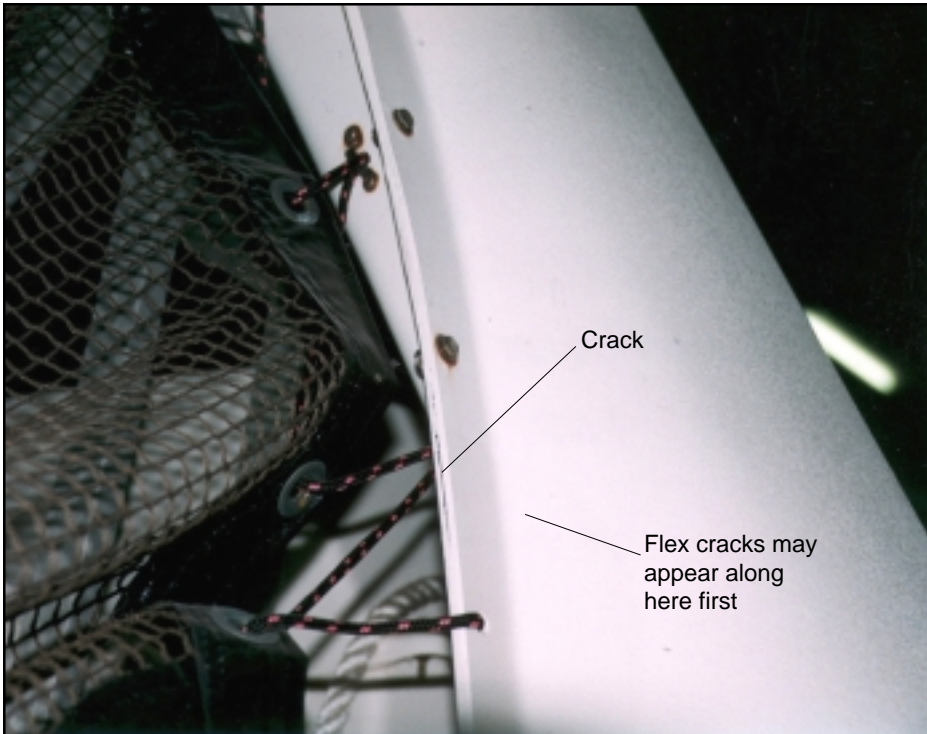
*This F-27 forward beam has the most commonly seen joint flange crack. While not initially serious, such cracks can quickly become serious if not repaired promptly. They should not be allowed to get any worse than this.*

The most common problem area has been on the horizontal forward flange join on the F-27 forward beams, at the outer end just inside the float. Beam break tests have shown that this area is actually put under a higher stress with more of a peeling load, rather than the usual shear loads, due to the curved beam shape in this area. Such a concentrated and more difficult load is more likely to find any weak areas.

Any failure seems to start at the inside aft edge of the flange, where the stress is highest, and some external flex cracks may first become visible, as per the drawing. The actual glue line crack then slowly makes its way forward to eventually become visible as a crack on the outside.

Should a crack be found, the repair is relatively easy **if done early**. The crack should be cleaned out by inserting a hacksaw blade or thin knife blade and moving it in and out to remove any loose debris, and roughen both surfaces. If using a knife, warp a strip of emery cloth or sandpaper over the knife. If a long crack, it can be levered apart a little for better access.

Then wedge apart with something like matchsticks and reglue using Lord Chemical's Fusor epoxy 320/322 glue

(available from Corsair Marine). This is the special high bond epoxy that can achieve an excellent bond even if surface preparation is poor, or mix ratio is inaccurate. If not available, any good epoxy will do, but prepare well and mix very carefully. Apply glue, using a paddle stick to force it into the join, remove any wedges and then clamp join lightly if necessary (but don't clamp too hard and squeeze all the glue out).

Once cured, the flange should then have additional bolts added as detailed, and again note that these are best located as far aft as possible.

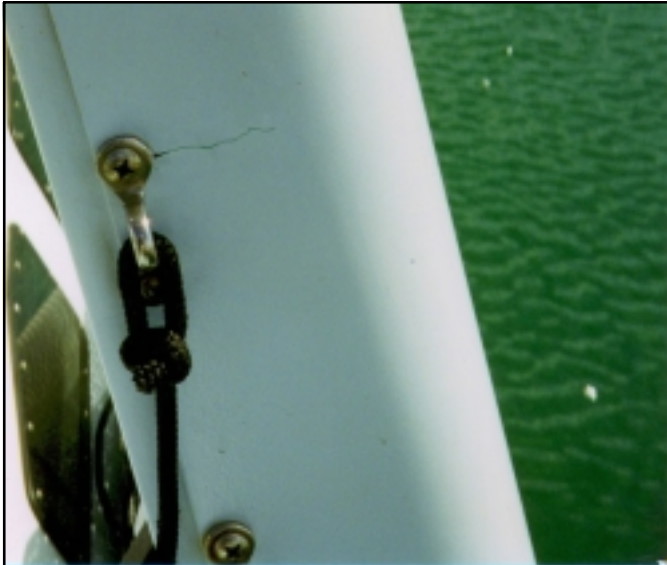
The vertical join line as used on both sides of the F-25A, F-31 or aft side of the F-27 and F-28 beams, are also areas to watch. Should the glue line fail here, and be undetected, the failure will grow along the join flange until it reaches a bolt, which then acts as a stress raiser. A vertical crack running up the side of the beam may then develop from that bolt. Now it gets serious and must be repaired without delay.

*This beam shows a vertical crack that may eventually develop from a vertical flange glue line failure if not seen and repaired early enough - now it becomes more serious*

Vertical cracks that have developed from a bolt on the side of a beam are still easily repairable, but procedure is a bit more complex as an additional backing plate has to be fitted inside the beam. Full details are available on request.

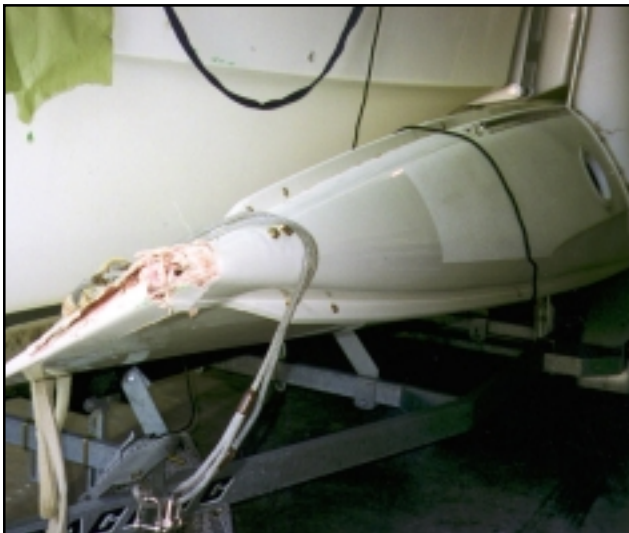
*Extensive damage to bow can be seen, plus cracks in fwd. beam*

*This F-27 hit a large steel marker buoy at high speed, but still survived. However, note extensive damage to bow, float hull and outer ends of beams. The join flange on the aft side of forward beam was also extensively delaminated and these beams had to be replaced. If such cracks were just gelcoat repaired then there would be a danger of sudden unexpected failure later.*

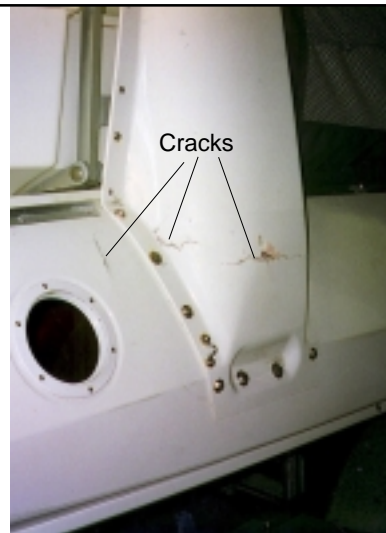
*Close-up of forward beam - this is too damaged to risk repair*

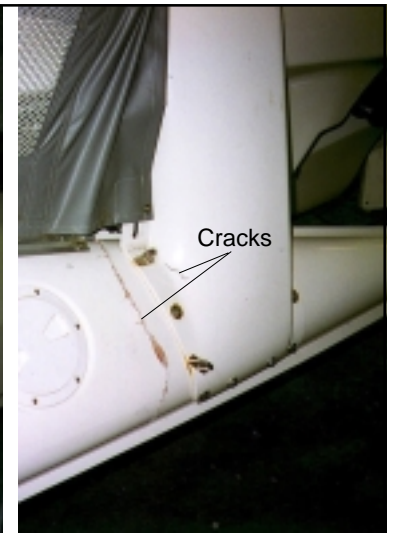
*Aft beam damage - note also large crack running around float deck*

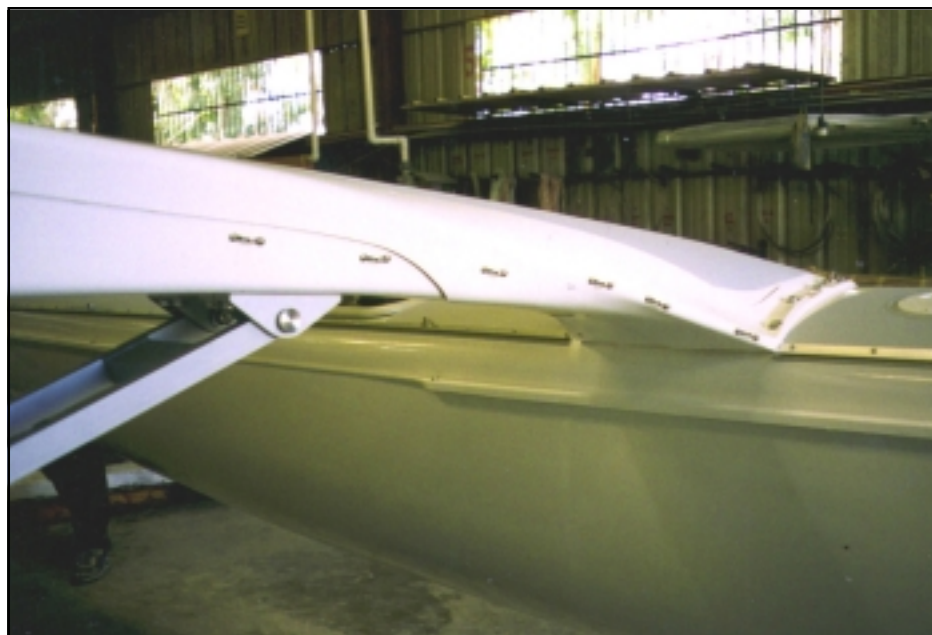
*The latest F-28 Fwd. Beam cover which eliminates the forward join flange.*

To help eliminate any reliance on glue bonds, the forward beam glue flange has now been removed on current F-28s. The join is now covered by an external cover, similar to that used on the aft beams, but with a more streamlined and appealing shape, and extending down to the float.

This can be retrofitted to earlier F-27s if wished, to also eliminate the join flange. It is just a matter of cutting the existing join flange off, filling and grinding the join seam smooth, taping over with glass tape, and then gluing on the new cover/fairing. However, the aft vertical join flanges will still need to be regularly checked.
