# BEAM & FOLDING SYSTEM - CARE AND MAINTENANCE

**FARRIER MARINE, INC.**

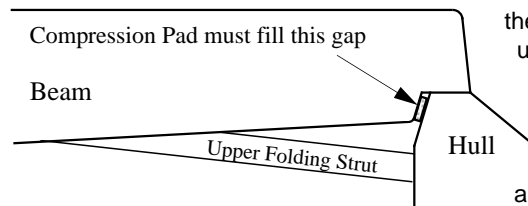
**Compression Pads:** All F-24, F-25, F-82, F-9A and F-31 owners should regularly check that the plastic compression pads on the inner ends of the beams are properly in position and fill the near vertical gap that may exist between the end of the beam and the pads on the hull. If any inwards movement is allowed here, the full compression

load on the beams is directed through the Upper Folding Strut mounting points which are not designed to take this load for long.

The Upper folding strut mounting points can then be damaged. However, although this does not threaten the boat's structural

safety, as the beam simply moves in slightly to bear directly on the hull, repairs can be expensive. Note that this gap will vary from boat to boat, and sometimes a compression pad may not be required.
